WARRENTON

Historic District Design Guidelines

TOWN OF WARRENTON, VIRGINIA

ADOPTED: February 28, 2008
AMENDED: January 14, 2014

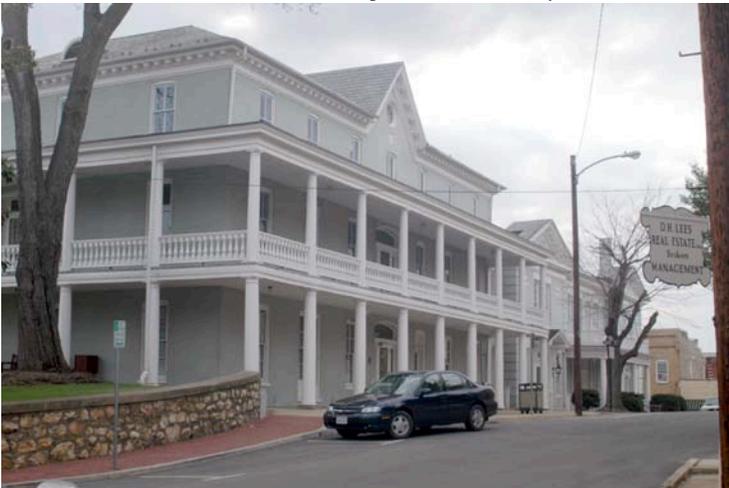
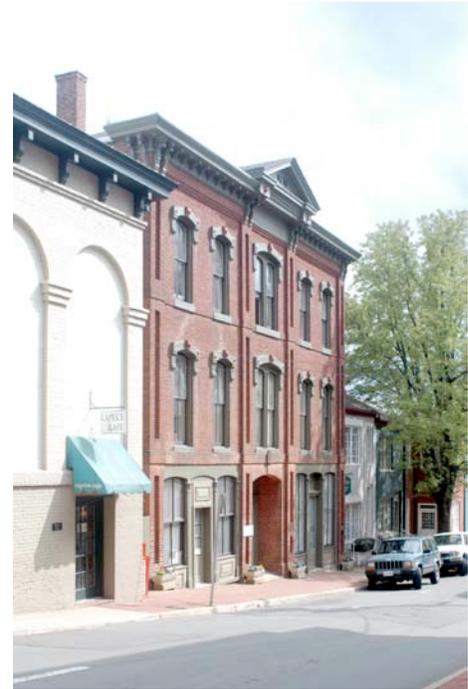
Masonic Building, 1876

Reconstructed in 1876 by John R. Spilman and bricklayer Bushrod Jolly after the 1874 fire

The most significant examples of late nineteenth-century commercial architecture include the Masonic Building at 7-11 Culpeper Street and the Warren Green Hotel at 14 Hotel Street. The Italianate style, three-story, brick Masonic Building demonstrates superb detailing with segmental-arched windows and paneled brick pilasters that support a heavy bracketed cornice and central pediment. Built in 1876 for the Masons who remained until about 1970, the Masonic Building is also noted for having the first elevator in the Town of Warrenton.

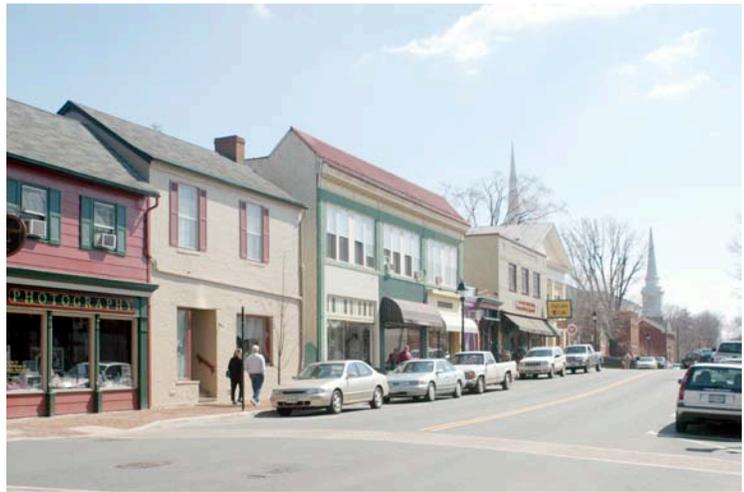
The Art Deco style is represented in three buildings on Main Street as shown here. Pitts Movie Theater Building with the red tile roof at center is flanked by the Western Union Telegraph Office on its left and Rhodes Drug Store on the right. The steeples of the original main block of the Warrenton Presbyterian and Warrenton Baptist churches rise in the distance.

Western Union Telegraph Office at 75 Main and Rhodes Drug Store, formerly Risdon's Hardware, at 77-79 Main Street represent this period. All built in the 1930s, the theater building is enhanced by a Spanish Colonial-style tile mansard roof.

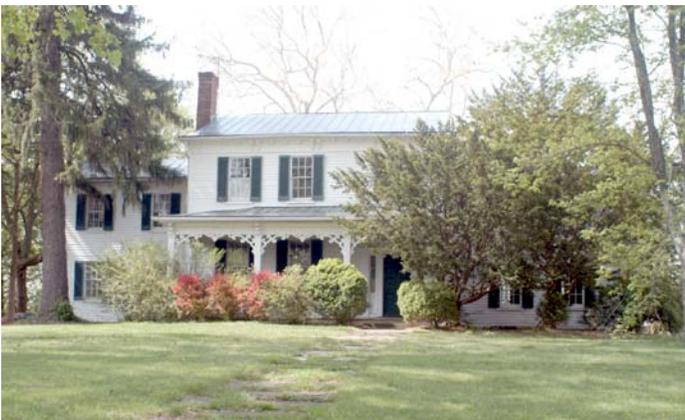
Built circa 1758 for Martin Pickett, Paradise is considered Warrenton's oldest residence. The porch, brackets and wing were probably added by William H. Gaines who owned the property in the nineteenth century.

Although Warrenton was settled in the mid-eighteenth century, few houses from that period survive today. One of the earliest and most distinguished in the district is the circa 1758 Federal-style Paradise (158 Winchester Street), the home of Martin Pickett who gave land for the courthouse and was a representative of the state convention of 1776 and the Virginia Constitutional Convention of 1788. Paradise is an excellent example of sympathetic design continuum from the mid-eighteenth through the late nineteenth centuries. Two important frame houses at 35 and 45 Horner Street on the estate of William Horner, a 1780 settler, appear to be of the late eighteenth century. Another significant early dwelling is within Joynes Funeral Home at 25 North Third Street. The central two-story, two-bay-wide, frame Federal-style portion with a rubble stone foundation is circa 1790.

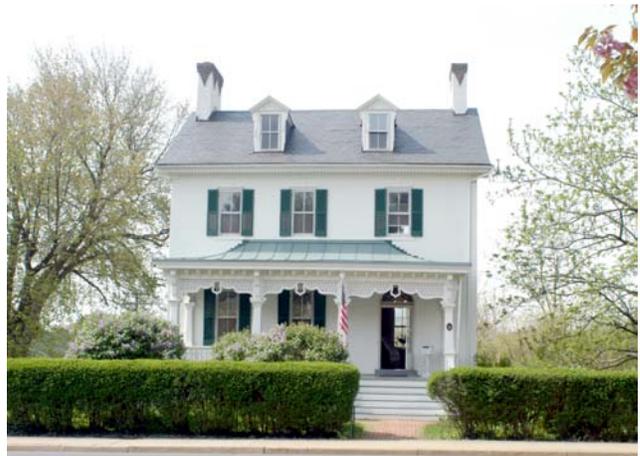
Architect William H. Baldwin designed the latticed porch also built by Mr. Spilman for attorney James Vass Brooke's Federal-style house.

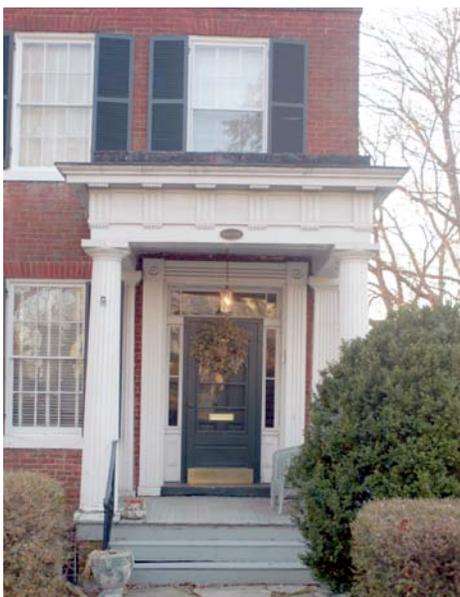
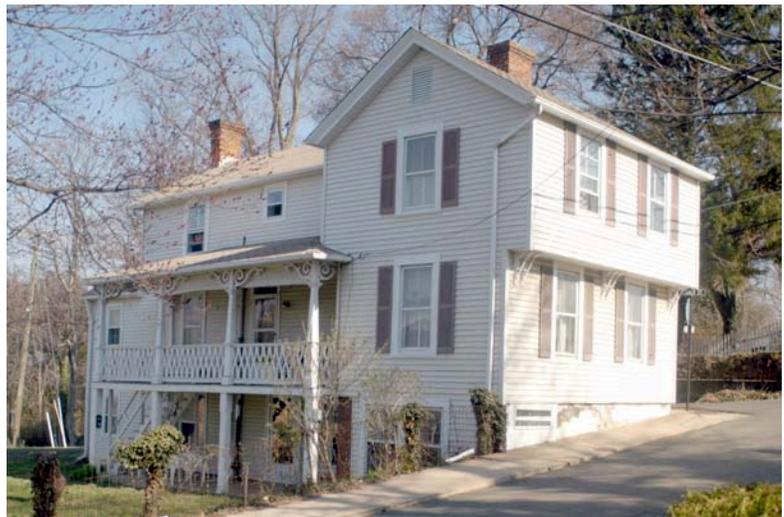
The William H. Jennings House has an elaborate Greek Revival-style entrance with a rectangular transom, sidelights, Doric portico with triglyphs and metopes in the frieze. The Vernacular house at 124 Horner Street has a fine New England Colonial-style overhang supported by paired spindle brackets, two-story rear porch with jigsaw balustrade and a scroll bracketed cornice.

Main Street has two notable houses in the Greek Revival style, the John T. James House (122 Main), a two-story brick townhouse with parapet gable ends and three refined Doric porticos with full entablature and the William H. Jennings House at 188 Main with its elegantly proportioned Doric portico, paneled brick parapet and refined window and door trim. The Dr. William Bispham house at 197 Main adds Gothic Revival-style importance to the streetscape with its central triple-pointed arched window. Further embellished with tracery, the residence holds prominence as the first dwelling seen from Falmouth. Although largely Italianate, Gothic details contribute to the Charles Payne House at 71 Winchester Street. More modest but significant houses of various ages are located along Lee Street between Fourth and Falmouth streets and along Horner, Falmouth, Waterloo and west of King Street on Winchester. There are several fine early twentieth-century Bungalows on all of these streets except for Horner. The historic district also includes numerous Vernacular residences that are as individually unique as the high styles for their value in demonstrating that Warrenton was also an agricultural town with ordinary hard-working people. The Warrenton Historic District even has a "House of Seven Gables" located at 189 Lee Street where the stone R. W. Hanback House is also noted for its asymmetry, steeply-pitched slate gable roof along with paired and tripartite windows.

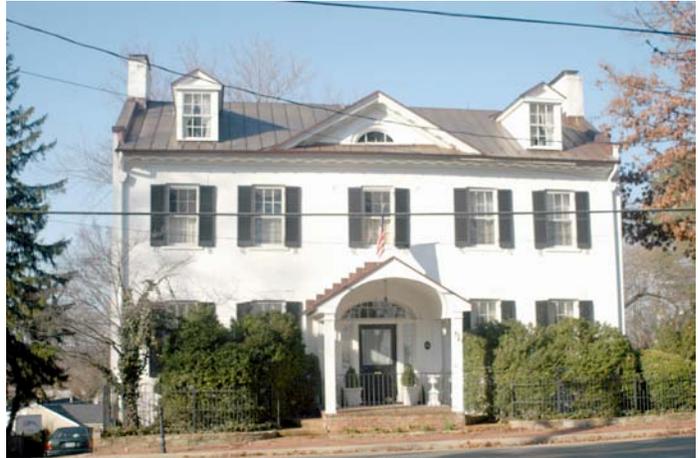
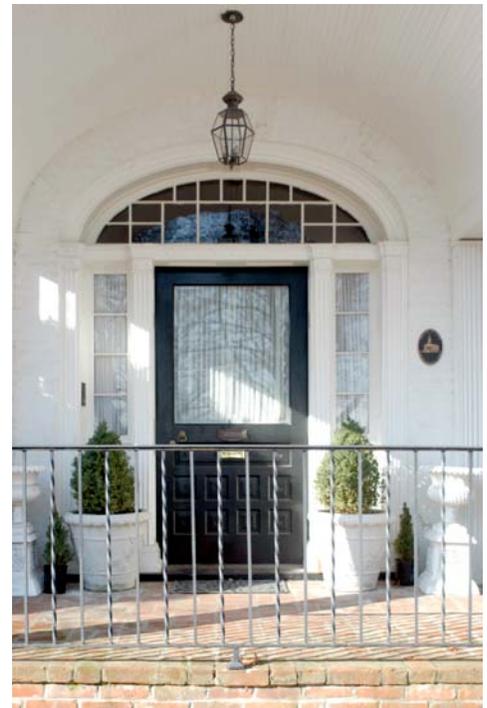
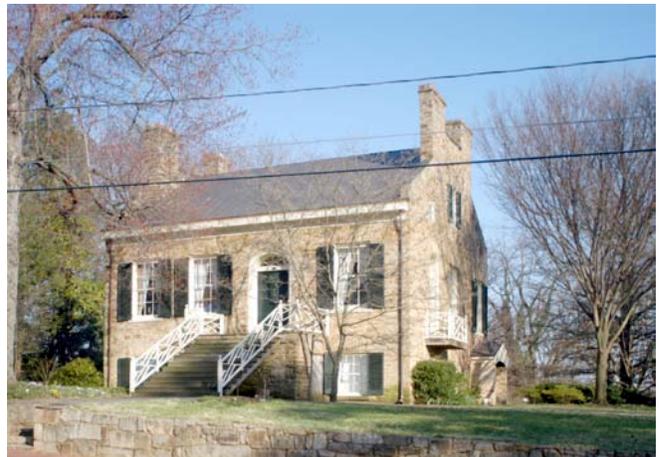
The brick Dr. Frederick Horner House at 66 Winchester Street and the stone Thomas L. Moore House at 127 Culpeper Street are two of the most important Federal-style dwellings in the historic district. The entrance on Dr. Horner's house shown in the middle picture is elaborated with sidelights, an elliptical transom with most unusual rectangular divided lights, fluted pilasters and a brick surround. The Doric cornice and central pediment with a half lunette are also fine features. The porch and dormers are a later addition. The Thomas L. Moore House has paired parapet chimneys, a fan above the door, an English basement and Chippendale railing flanking the tall stairway.

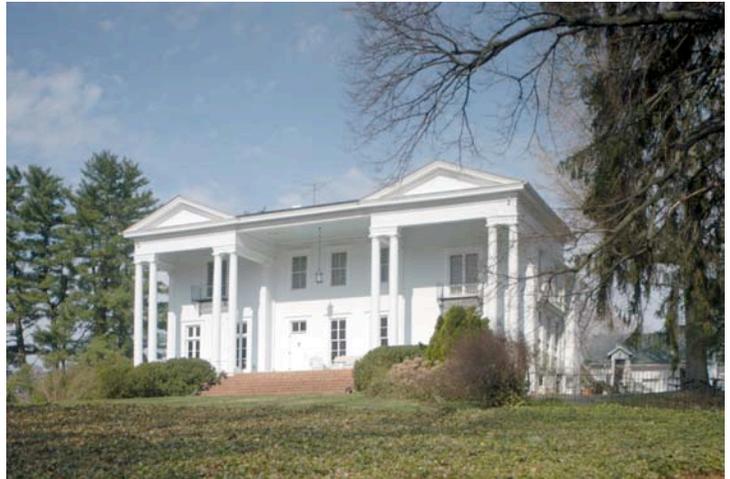
Menlough on Springs Road is a superb, but late, example of the Classical Revival style with its paired, two-story, four-columned, pedimented porticos, classical molding and tall windows. The wide cornice band is a Greek Revival-style detail.

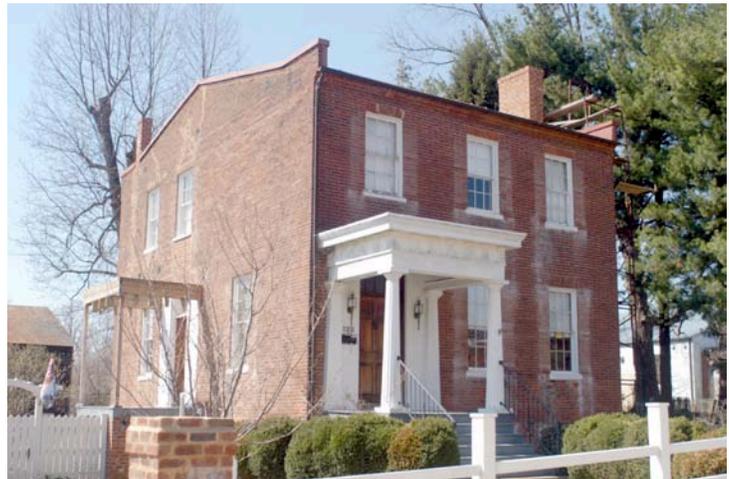
The John T. James House at 122 Main Street has three Doric porticos, although the two side porches are under repair in this current photograph. The characteristic low-pitched roof is well articulated and enhanced with parapets.

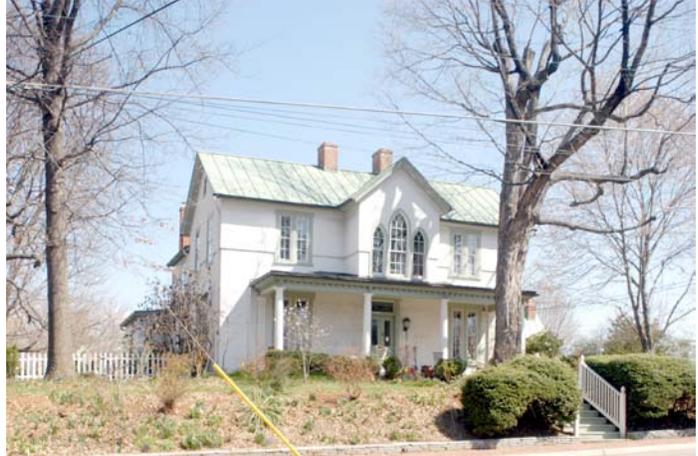
Now stuccoed, the Dr. William Bispham House, circa 1856, 197 Main, originally had Carpenter Gothic-style batten over vertical boards. The projecting centered gable is decorated with a triple-pointed arched window and tracery.

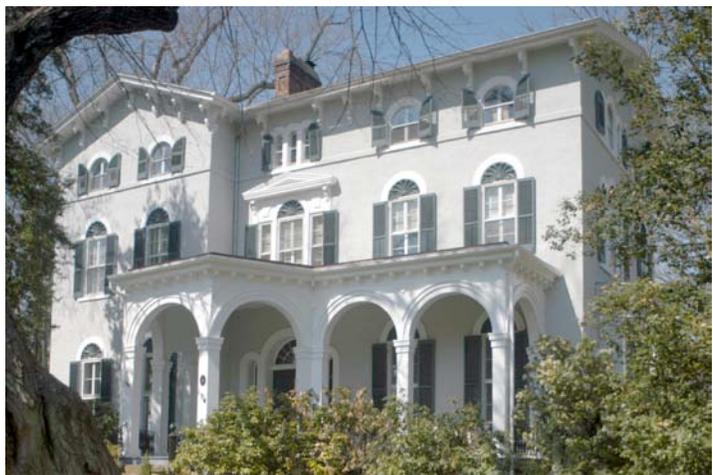
Mecca, built in 1859 for attorney Rice W. Payne at 194 Culpeper Street, is the most architecturally embellished Italianate-style house in the historic district.

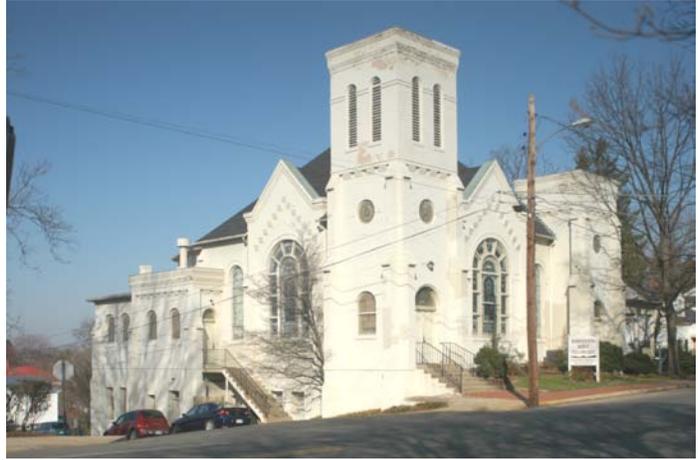
Built in 1911 at 144 Winchester Street, the Warrenton Methodist Church has every characteristic of the Romanesque Revival style.

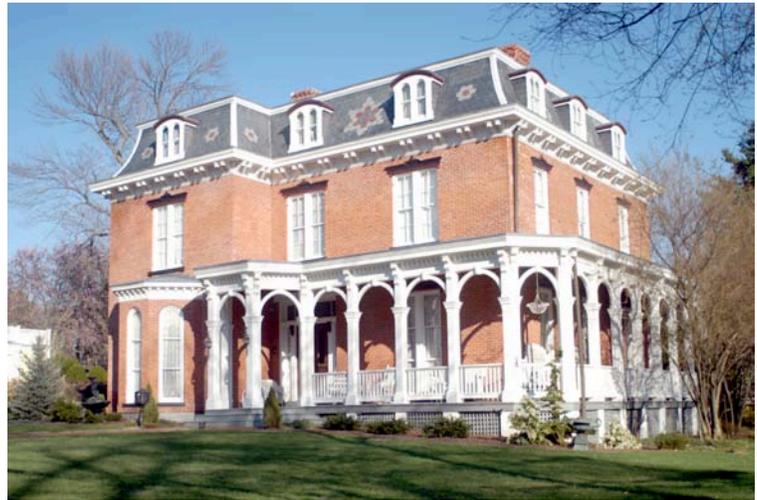
The circa 1857 Ullman House at 157 Culpeper Street is another masterpiece of builder John R. Spilman. It features a multi-colored pattern on the slate mansard roof, a flared eave, bracketed cornice, elliptical dormers, tall hooded windows, an asymmetrical L-plan and an arcaded porch.

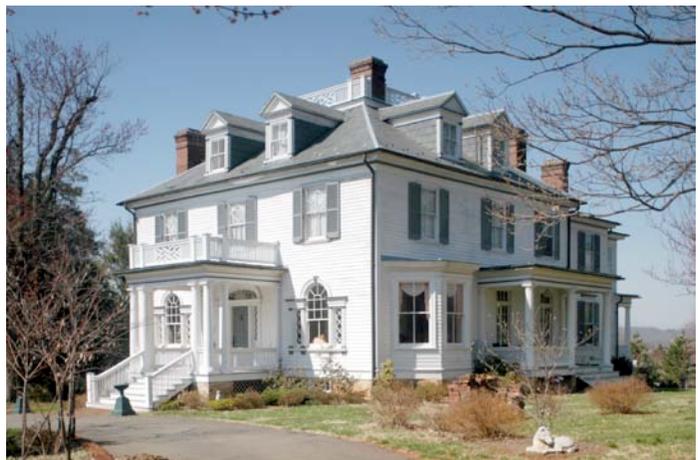
Also a Georgian Revival style, the circa 1905 John Wise House at 100 Culpeper demonstrates an exaggeration of the Palladian window with two flanking the entrance.

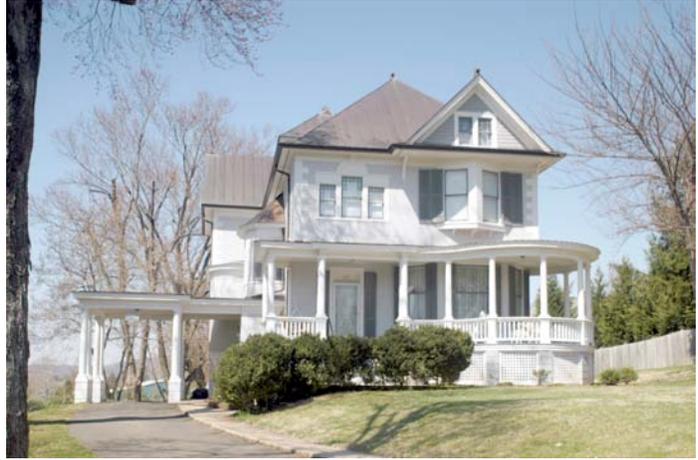
The Dr. Martin Douglas House at 158 Culpeper Street with shingled projecting gables, multi-pane windows, a seven-bay, curvilinear, wraparound porch and a one-story porte-cochere is the best Queen Anne in the historic district. Neglected for many years, the house has recently been sympathetically restored.

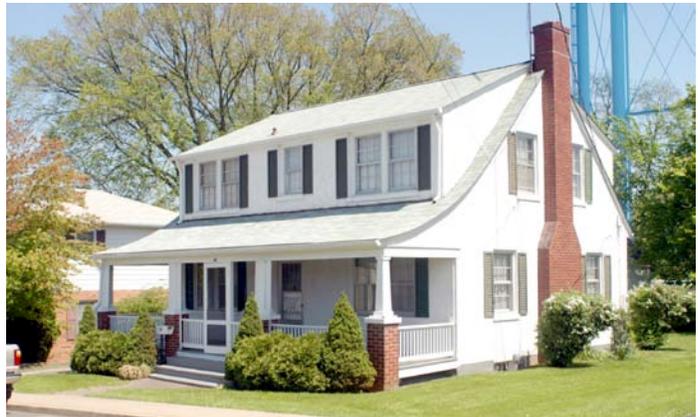
While this Bungalow at 35 North Third Street does not have Craftsman-style extended rafters, ridge beams and purlins, it shows a broad gable covering the porch roof supported by battered wood columns on masonry piers and paired windows in the shed-roofed, full-width dormer.

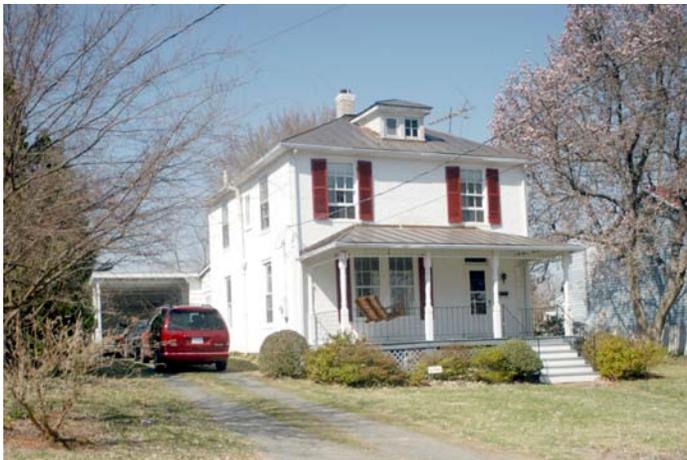
Stuccoed two-story, two-bay, American Foursquare W. H. Risdon House, 192 High Street.

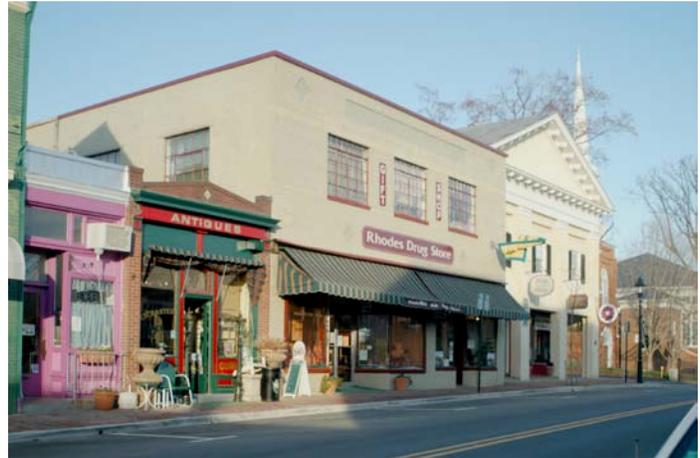
Rhodes Drug Store at center and the former Western Union Telegraph Office on the left represent the Art Deco style in the historic district. Rhodes has inset rectangular panels and diamond lozenges, while the telegraph, now antiques, building has a low chevron gable flanked by vertical parapets and a diamond center ornament below the peak.

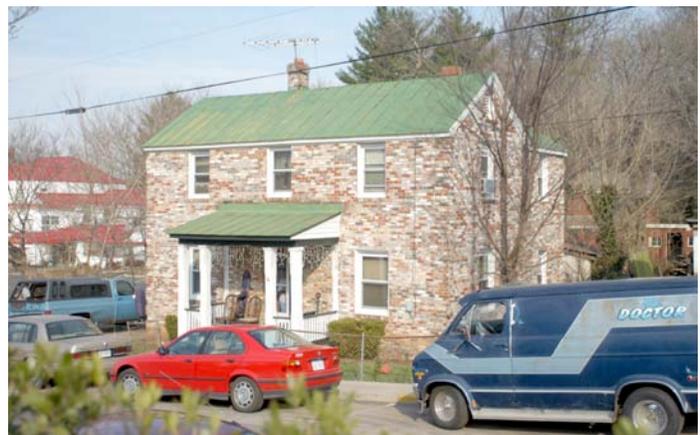
This circa 1890, two-story, three-bay, Vernacular I-House on Diagonal Street achieves design and detail with multi-colored brick veneer, raised quins and the porch supported by paired columns.

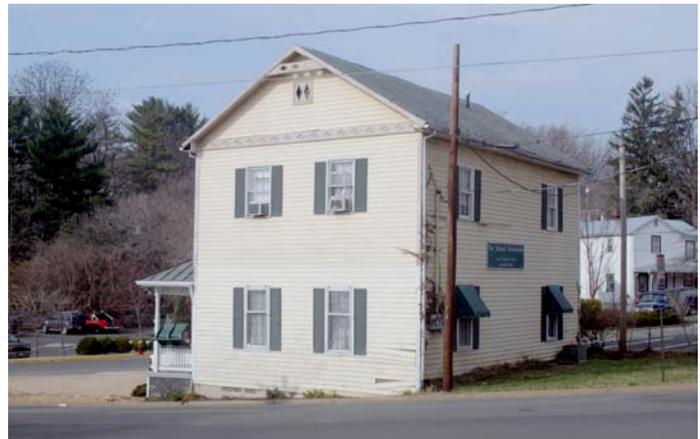
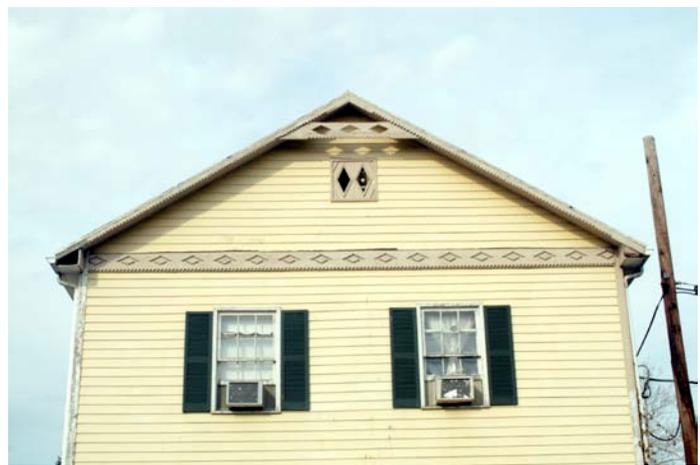
Presently the Natural Food Market on Diagonal Street, this circa 1850 Vernacular house became Moses Hall, the black fraternity lodge, in 1883. Details include turned balusters on the front porch and the unusual saw-tooth woodwork on the gable ends.

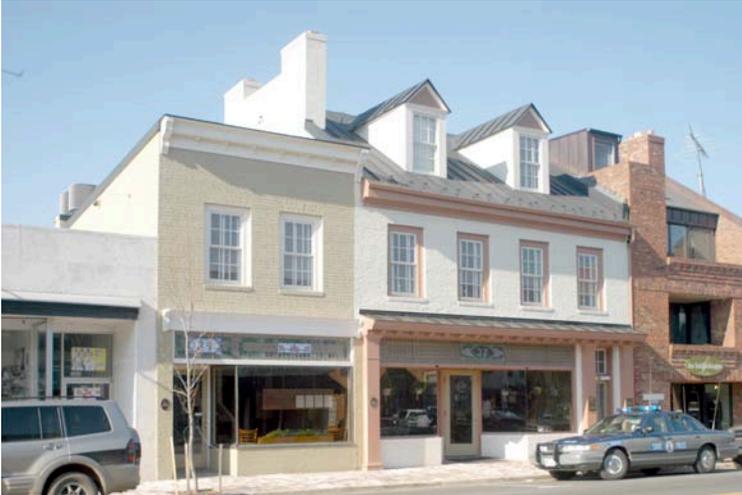
Recently rehabilitated, the 32-34 Main Street buildings are good examples of typical early-to-mid-nineteenth century store/houses. Their upper cornices are detailed with brackets and molding, the six-over-six, double-hung sash wood windows on the second story indicate the residential use and the street-level storefronts have typical large-pane display windows, recessed entrances, glazed transoms and cornice definition.

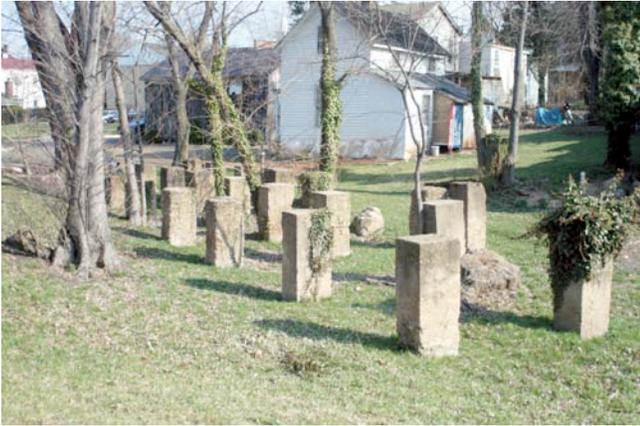
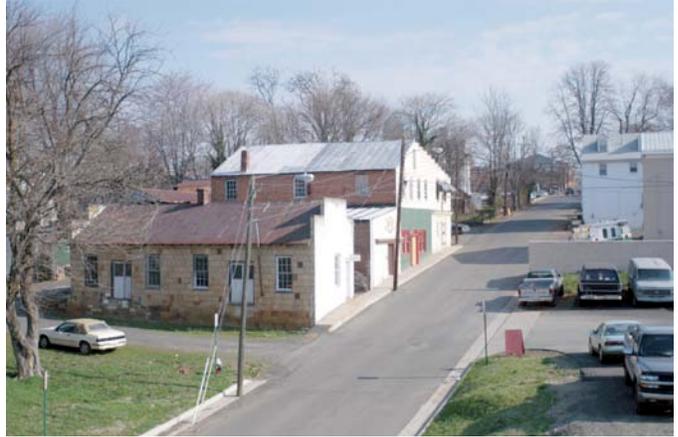
COMMERCIAL GENERAL DISTRICT AND HISTORIC RAIL YARD VIEWS FROM THE WARRENTON BRANCH TRAIL

Concrete piers of the demolished Warrenton Planing Mill warehouse should be preserved in situ as a reminder of the significance of the railway to commerce and industry. The planing mill and Thyson's Gristmill on South Fifth Street are seen in the right photograph. Automotive repair businesses stand across the street.

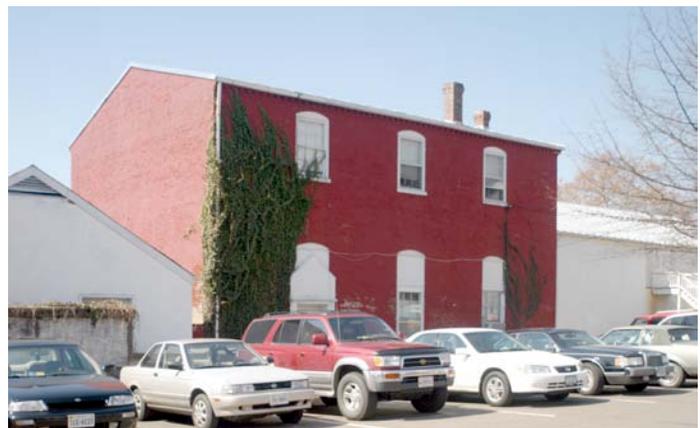
Do not allow ivy or other tendril foliage to grow on a building. The tendrils cause structural damage as shown below on the foundation of the first St. John's Catholic Church on Lee Street.

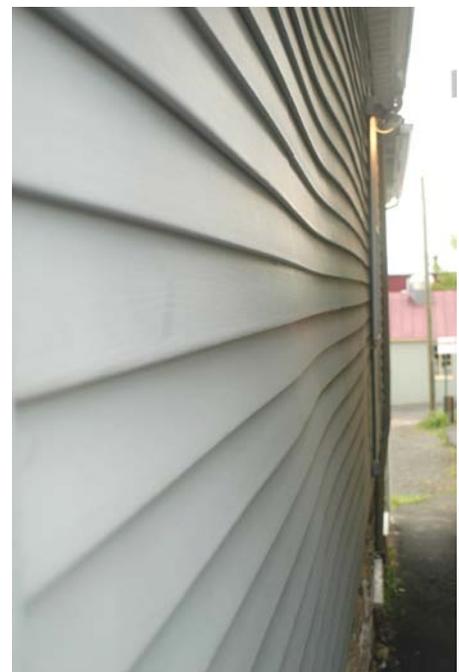
Vinyl siding applied over the weatherboard on the E. N. Cologne frame building at 68 Main Street, shown in the photograph on the right, clearly demonstrates how this synthetic material warps. Such rippling is uncharacteristic of the appearance of natural wood weatherboard.

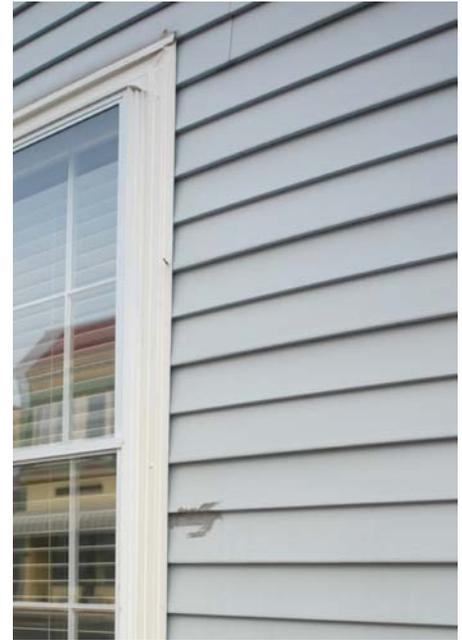
Patch in the vinyl siding on the façade of the E. N. Cologne Building. The depth and detail of the wood window frame is obscured by a vinyl covering.

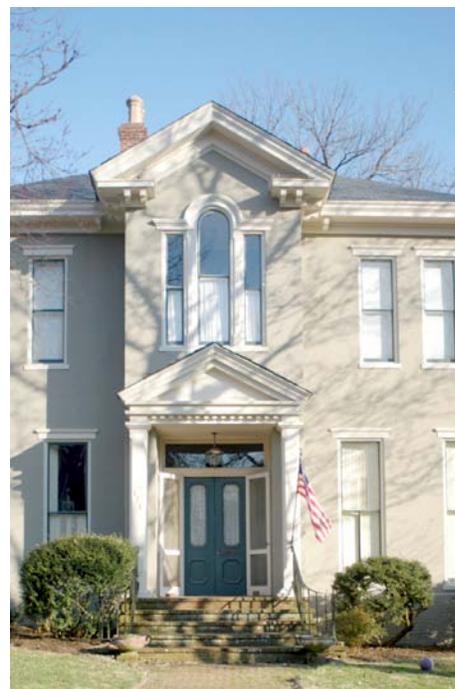
Joseph H. Nelson House, 171 Culpeper Street. Its central projecting pavilion has a Palladian window and a pedimented portico with a recessed double-leaf door.

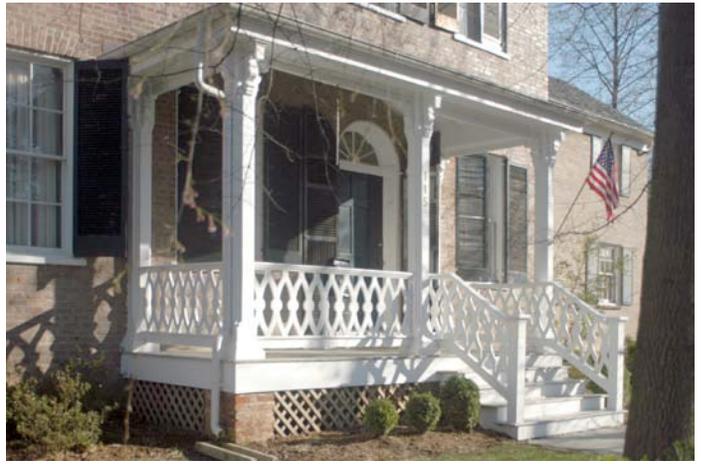
This one-story, two-bay porch with an intricate jigsaw balustrade, chamfered posts and scroll bracketed cornice was added to the Federal-style Dr. H. Clay Ward House at 115 Culpeper Street later in the 19th-century.

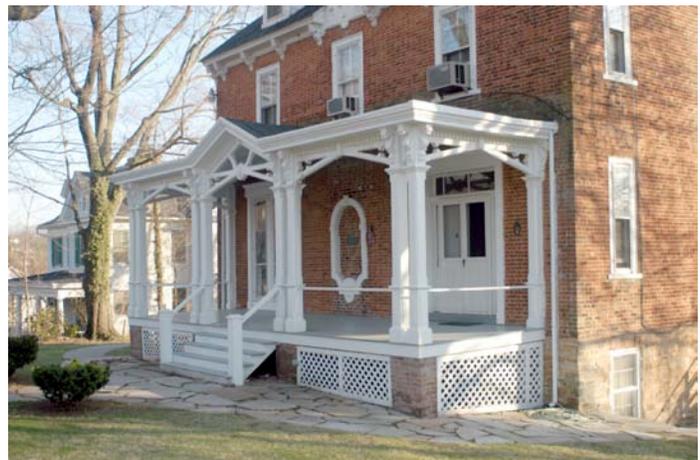
This richly-detailed Italianate-style porch was added to the Federal-style, circa 1830 Robert Brent House at 114 Lee Street, during General William H. F. Payne's 1866-1901 ownership.

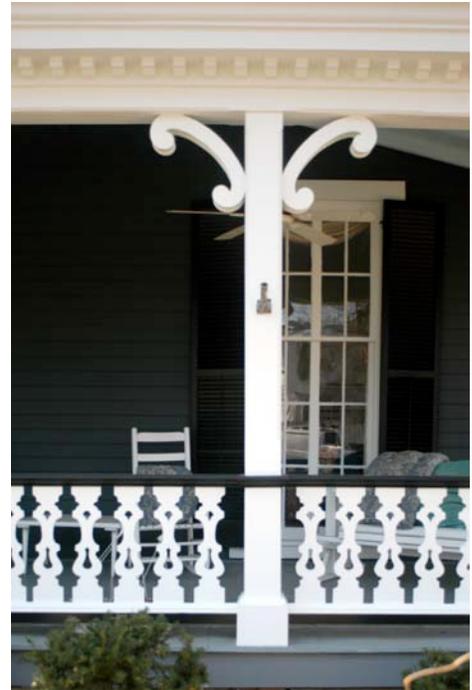
The porch on the excellent Italianate-style frame house at 178 Main Street has an intricate jigsaw balustrade, chamfered columns and infrequent C-scroll brackets supporting the bracketed cornice.

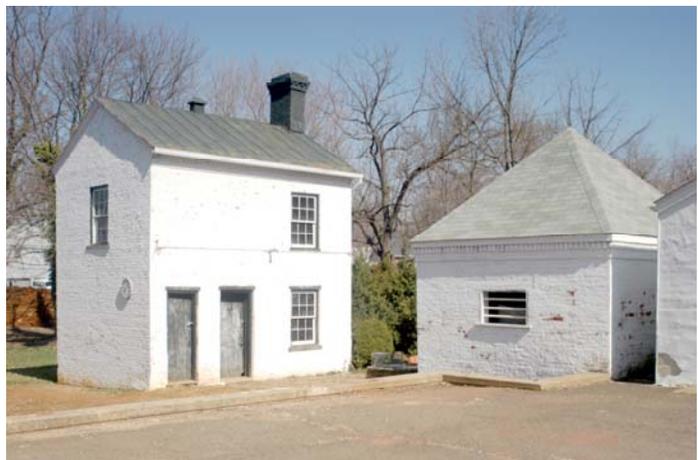
The corbelled brick chimney on Brentmoor's summer kitchen is an unusual elaboration for a utility outbuilding.

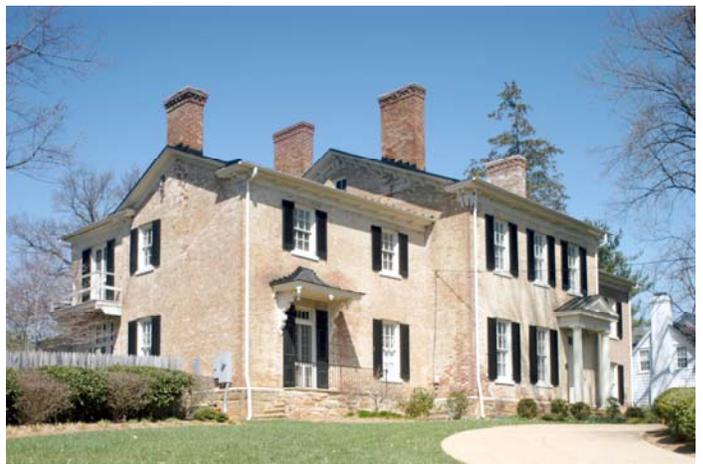
This two-story, two-bay-wide brick wing on the Alexander Day House at 140 Culpeper Street is an excellent addition, being subordinate in height, width, depth, scale and setback. Its materials and design are compatible, the sash windows are in scale and pattern and its entrance is subordinate to the Federal-style portico. Thus, the main block remains the focus of the building.

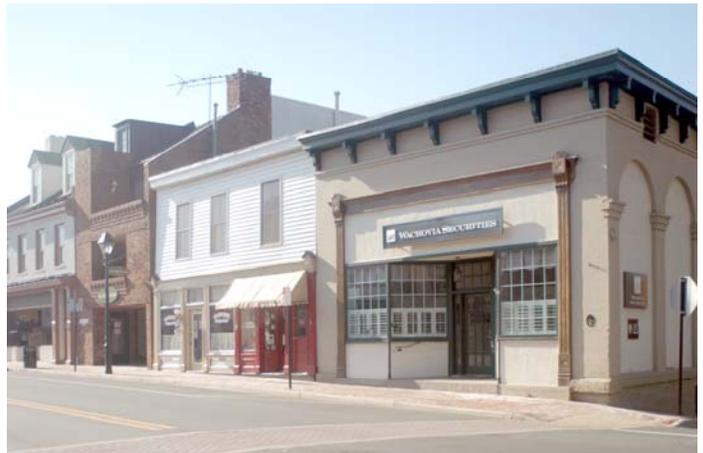
The buildings on the corner of Main and Culpeper streets relate in proportion, scale, spacing, massing, form, height, width and setback. The divided lights in the storefront windows of the corner building were added prior to creation of the historic district.

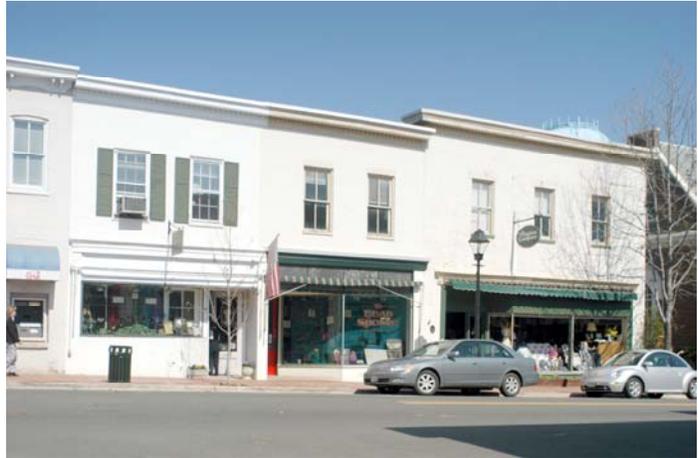
41, 43, 45 Main Street. Although the facades of 41 and 43 are on the same plane, differentiation of paint color distinguishes them as two separate storefronts.

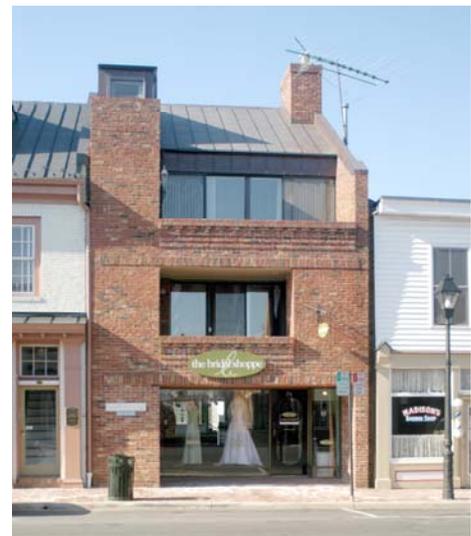
Stepped and sloped side walls with a set back 3rd story achieves compatible height to each adjacent building.

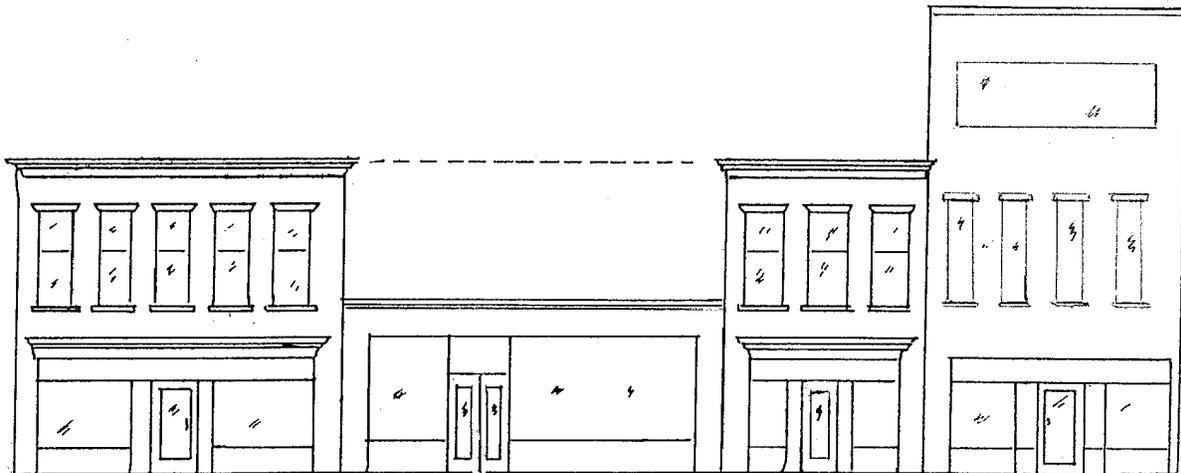
Inappropriate new construction that is not in scale, proportion, size or rhythm to the historic store/houses. The dashed line indicates the typical building height for this store/house block. The second infill building is too short, and the horizontality of the fenestration does not repeat the rhythm of the adjacent storefronts. The tall infill building on the right dominates the historic buildings, and its horizontal third-story windows do not replicate the residential theme, while the narrowness of the second-story windows accentuates the vertical height of the new construction.

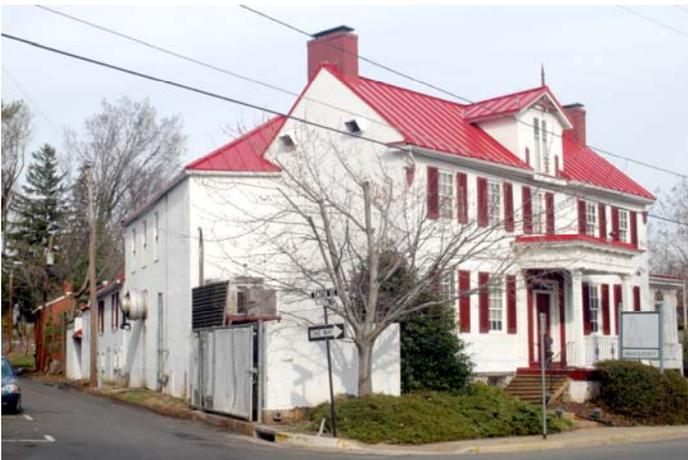
A visible restaurant exhaust fan is shown on the street side of the former Gen. Eppa Hunton House at 67 Waterloo Street. The fan was later repositioned.

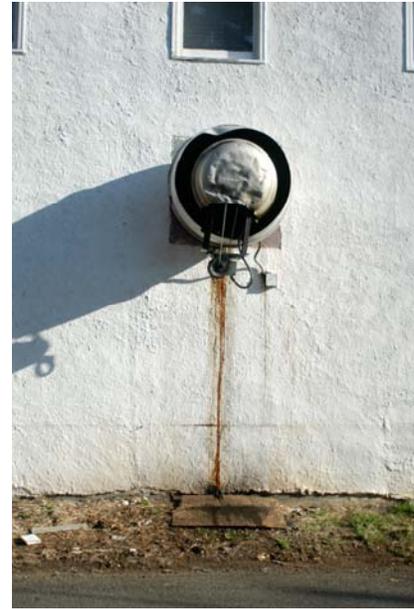
Unsightly grease and condensation drips can cause material damage and deterioration.

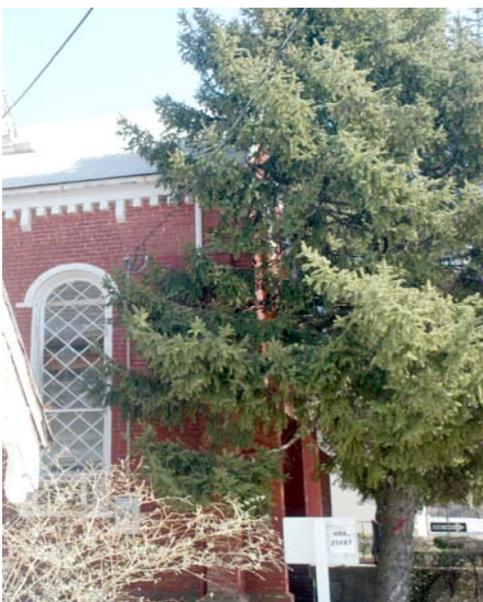
Evergreens are hazardously growing into St. John's Catholic Church on Lee Street.

The former St. John's Catholic Church on Lee Street is a prime example of the considerable damage that trees and vines can cause when planted too close to historic buildings. The damages are repairable, but such landscaping threats to the structural system and materials should be carefully and quickly removed when discovered.

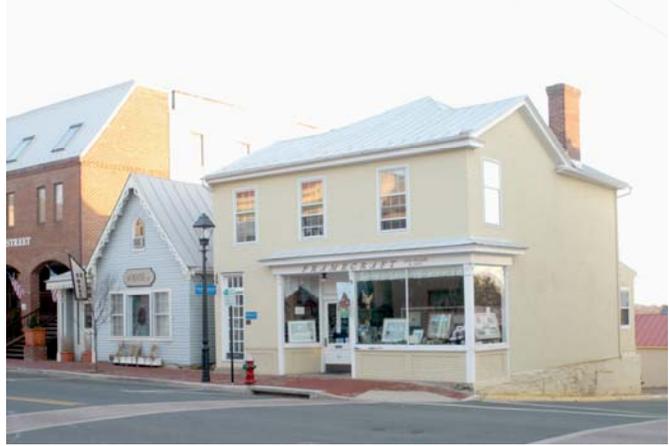
The cornice frieze serves as Framecraft's signboard. A wall sign was chosen by 68 Main on the adjacent E. N. Cologne building.

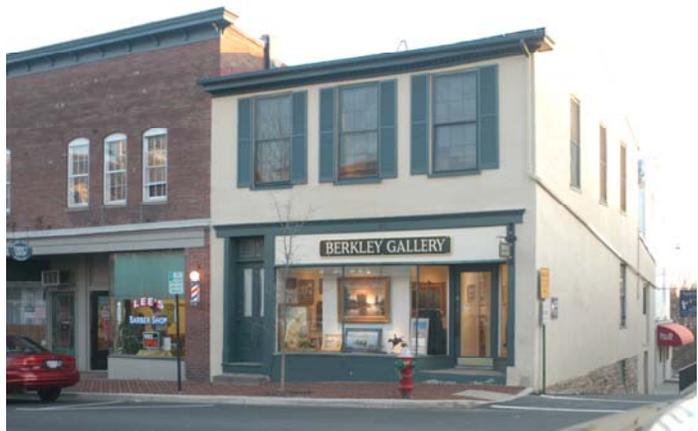
Berkley Gallery utilizes a transom sign. Lee's Barber Shop has a window sign and a symbolic barber shop pole.

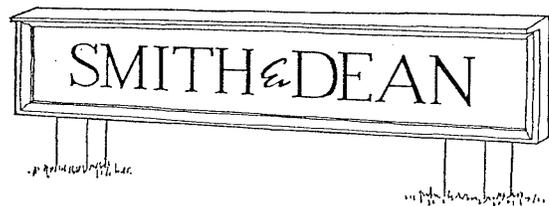
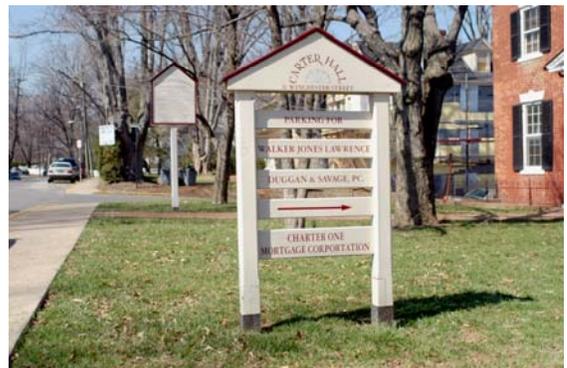
Well-designed ground signs in the ample front yard of Carter Hall

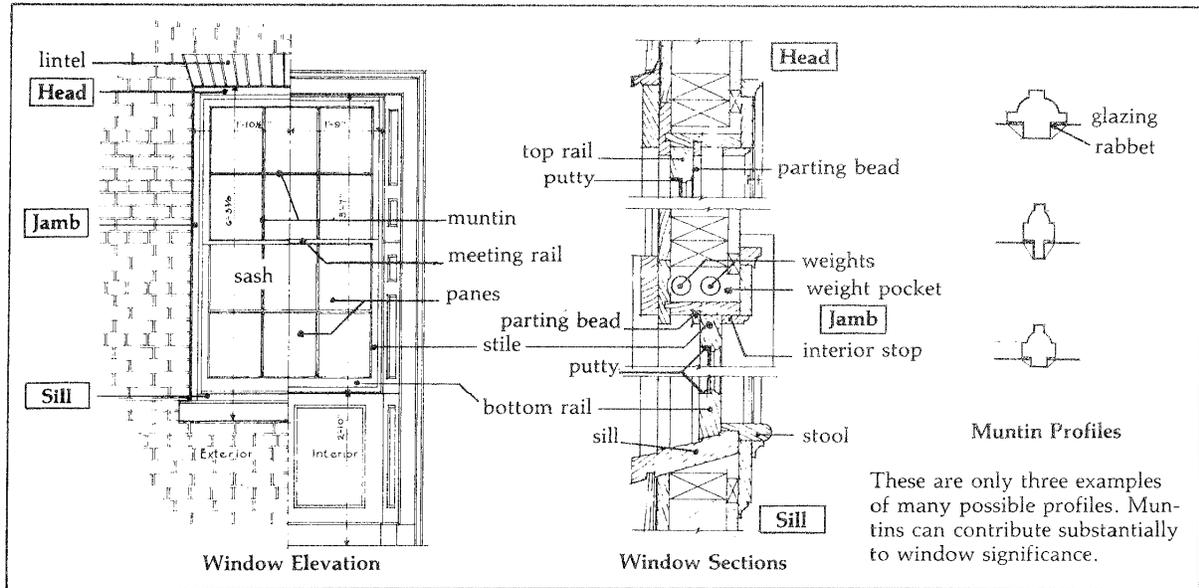
A six-over-six, double-hung sash window as shown in *Preservation Brief 9: The Repair of Historic Wooden Windows*

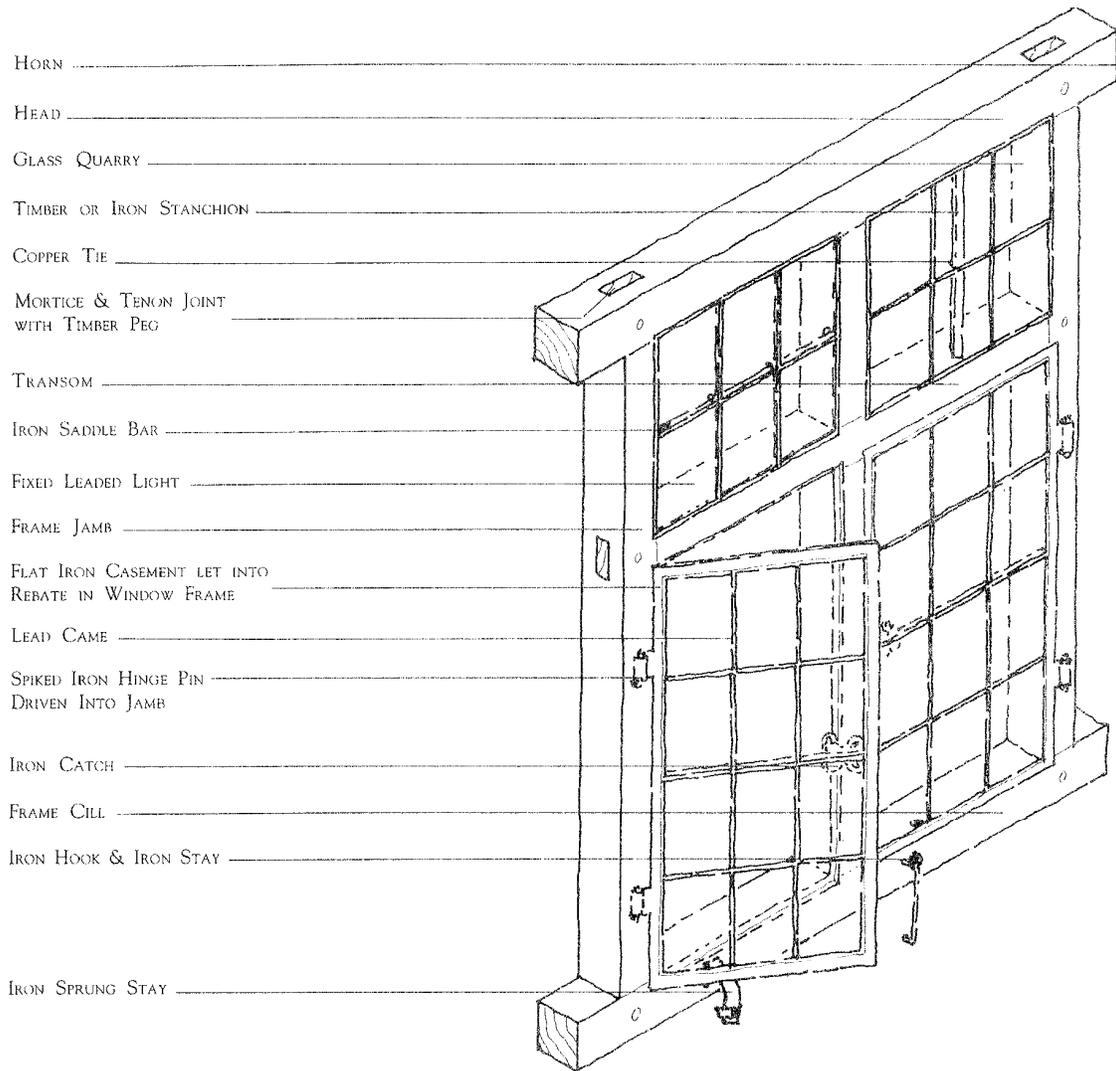
A twelve-light casement window with a transom above from *Technical Pamphlet 13. The Repair of Wood Windows*
